# Thermal Barrier Coatings

## Workshop

NASA Lewis Research Center  
Cleveland, Ohio

Abstracts  
and Figures

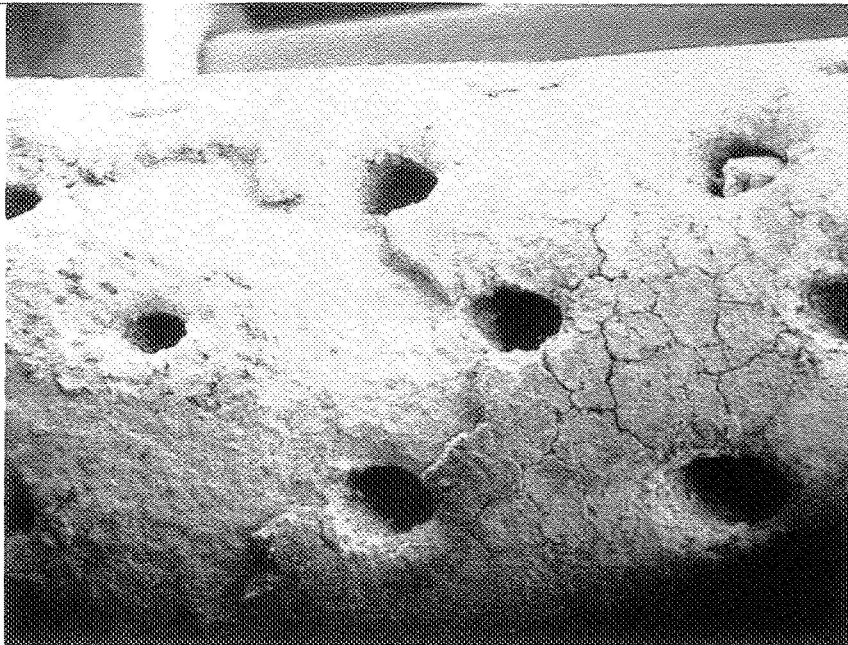
Figure 3.

## TYPICAL THERMAL BARRIER COATING FAILURE MODE

An initial review of experimental and flight service components indicates that the predominant mode of TBC failure involves thermomechanical spallation of the ceramic coating layer. This ceramic spallation involves the formation of a dominant crack in the ceramic coating parallel to and closely adjacent to the metal-ceramic interface.

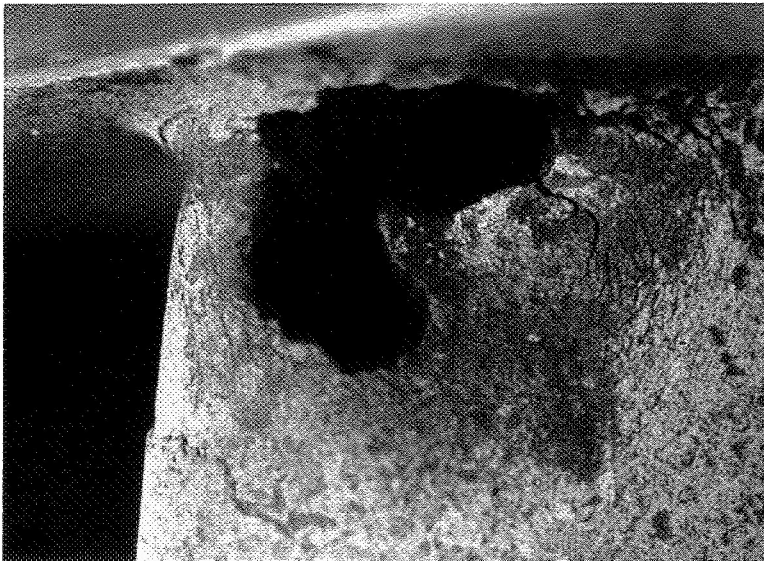
Figure 7.

TURBINE VANE TRAILING EDGE

"DAMAGED COATING"

METAL SMEARED ON INTACT COATING

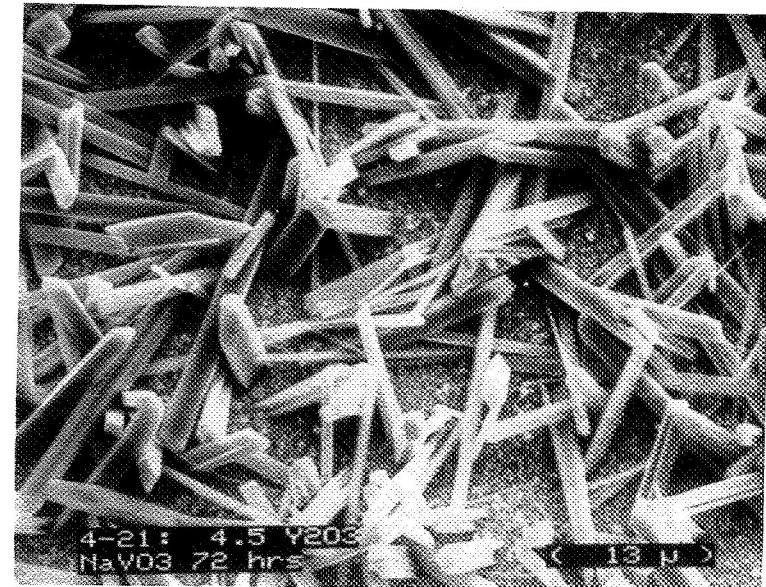
Figure 9.

# DEGRADATION OF $\text{Y}_2\text{O}_3\text{-ZrO}_2$ BY $\text{NaVO}_3$ AT $700^\circ\text{C}$

Examination of  $Y_2O_3$ - and  $CeO_2$ -stabilized  $ZrO_2$  sintered ceramics which were degraded in 700°C  $NaVO_3$  has shown good agreement with the reactions predicted above, except that the  $CeO_2$ - $ZrO_2$  ceramic appears to be inexplicably degraded by  $NaVO_3$ .
